JOHANNESBURG SOUTH SEISMIC EVENTS | Gauteng | South Africa

29 JUNE 2024 – 01 JULY 2024

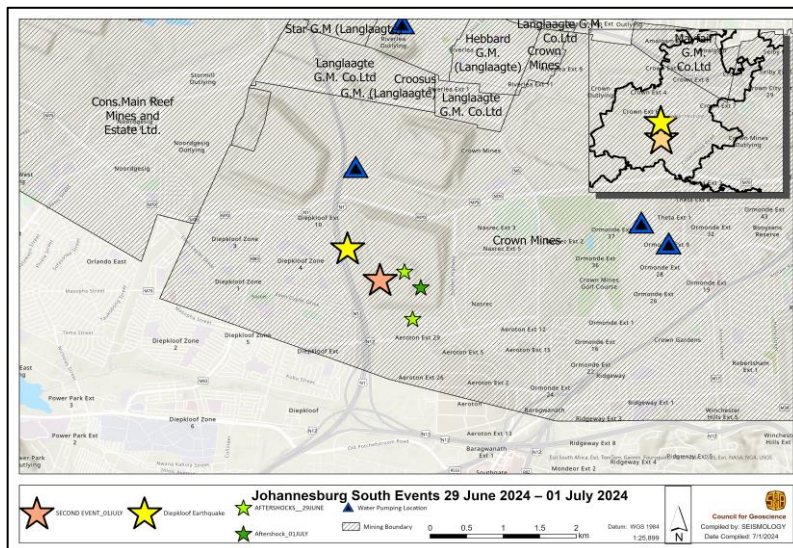
EPICENTRAL REGION

The epicentres are situated within the Central Rand mining boundary, within proximity to the ceased Crown Mine. The map shows the two main events in yellow and orange and the aftershocks in green. The blue triangles show previous water pumping stations.

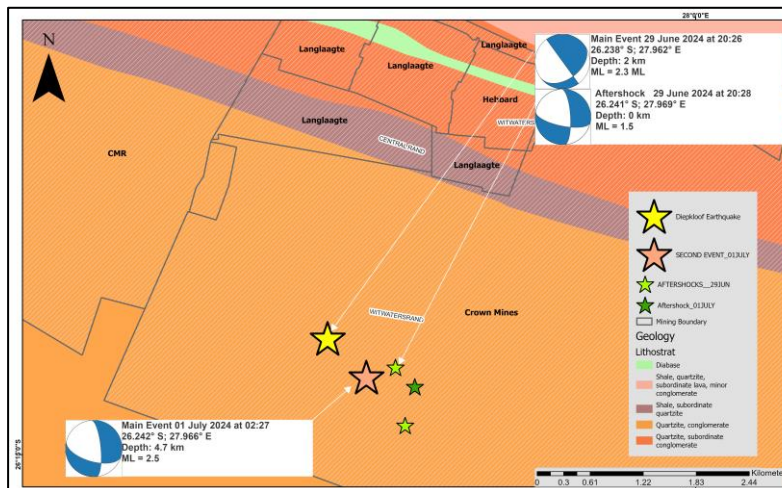
GEOLOGICAL SETTING

The epicentre region is underlain by basement units from the Quaternary deposits. Composed primarily of sediments of the Witwatersrand Supergroup. Partly covered by granitic rocks of the Archaean age. The focal mechanism shows a strike-slip faulting NE/SE.

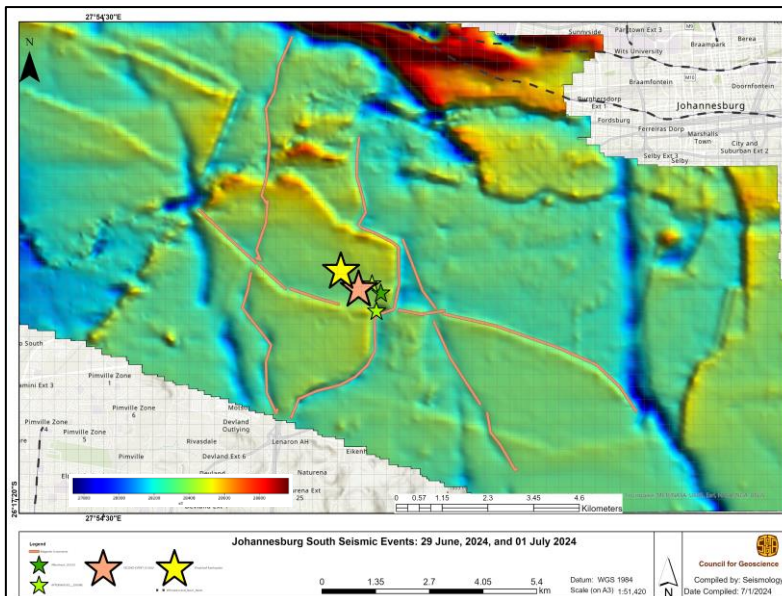
REGIONAL STRUCTURES

Our preliminary seismic findings indicate that the probable epicentral area (Mooifontein tailings dams located southwest of Johannesburg CBD) could lie between a network of fault or fracture structures that are intersecting each other (as shown on the magnetic map) and over time these structures could fail due to the weight exerted by of the tailing dams' stockpile of waste material. This is evident from the fault plane solutions, of the main events and aftershocks, which show a strike-slip normal fault focal mechanism and stresses oriented approximately northeast-southwest. Another hypothesis suggests that past precipitation could form a water table within the tailing's stockpile. Water infiltration through conduits could easily cause differential movements within the stockpile, leading to stress redistribution in underground fault/fracture structures and triggering of seismic events.

A total magnetic intensity map in the region, showing the interpreted intersection of the lineaments near the seismic events

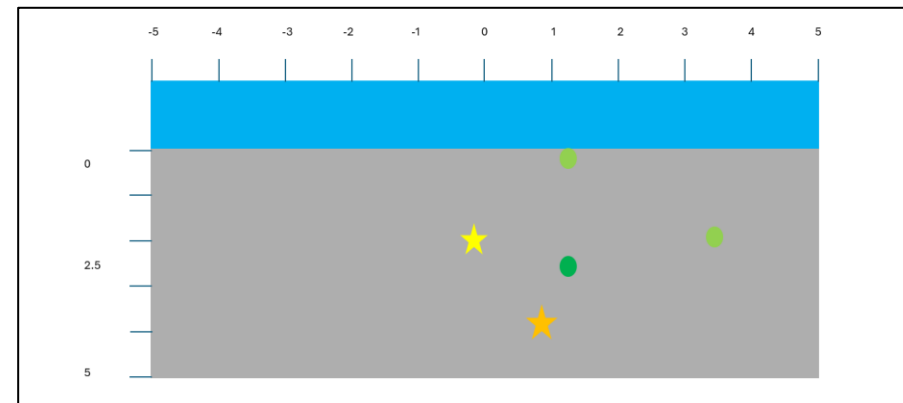
DEPTH PROFILE

A depth profile (x-axis and y-axis in kilometres) showing all the approximated depths of the events that occurred between 29 June 2024 – 01 July 2024. These events are all relative to the event on 29 June 2024 at 20:26:43.1
